Town of Montville Inspection Report

Date: 10/15/2025 Inspection Type: Wetlands Complaint

Location: 428 Fire Street Map/Lot/Block: 014-003-000

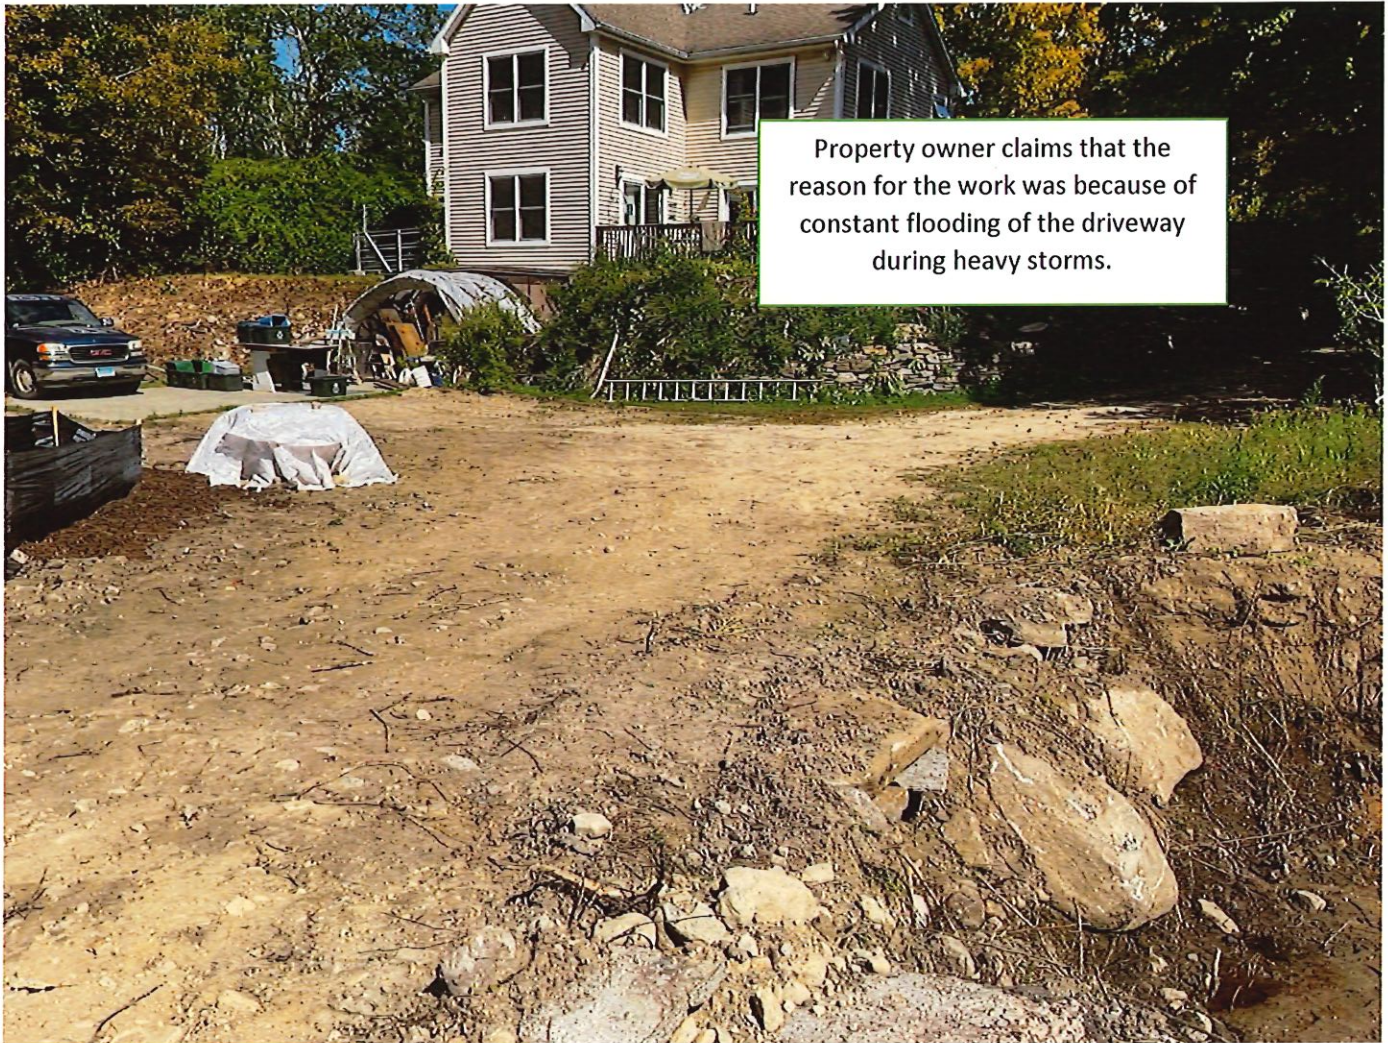
Property owner claims that the reason for the work was because of constant flooding of the driveway during heavy storms.

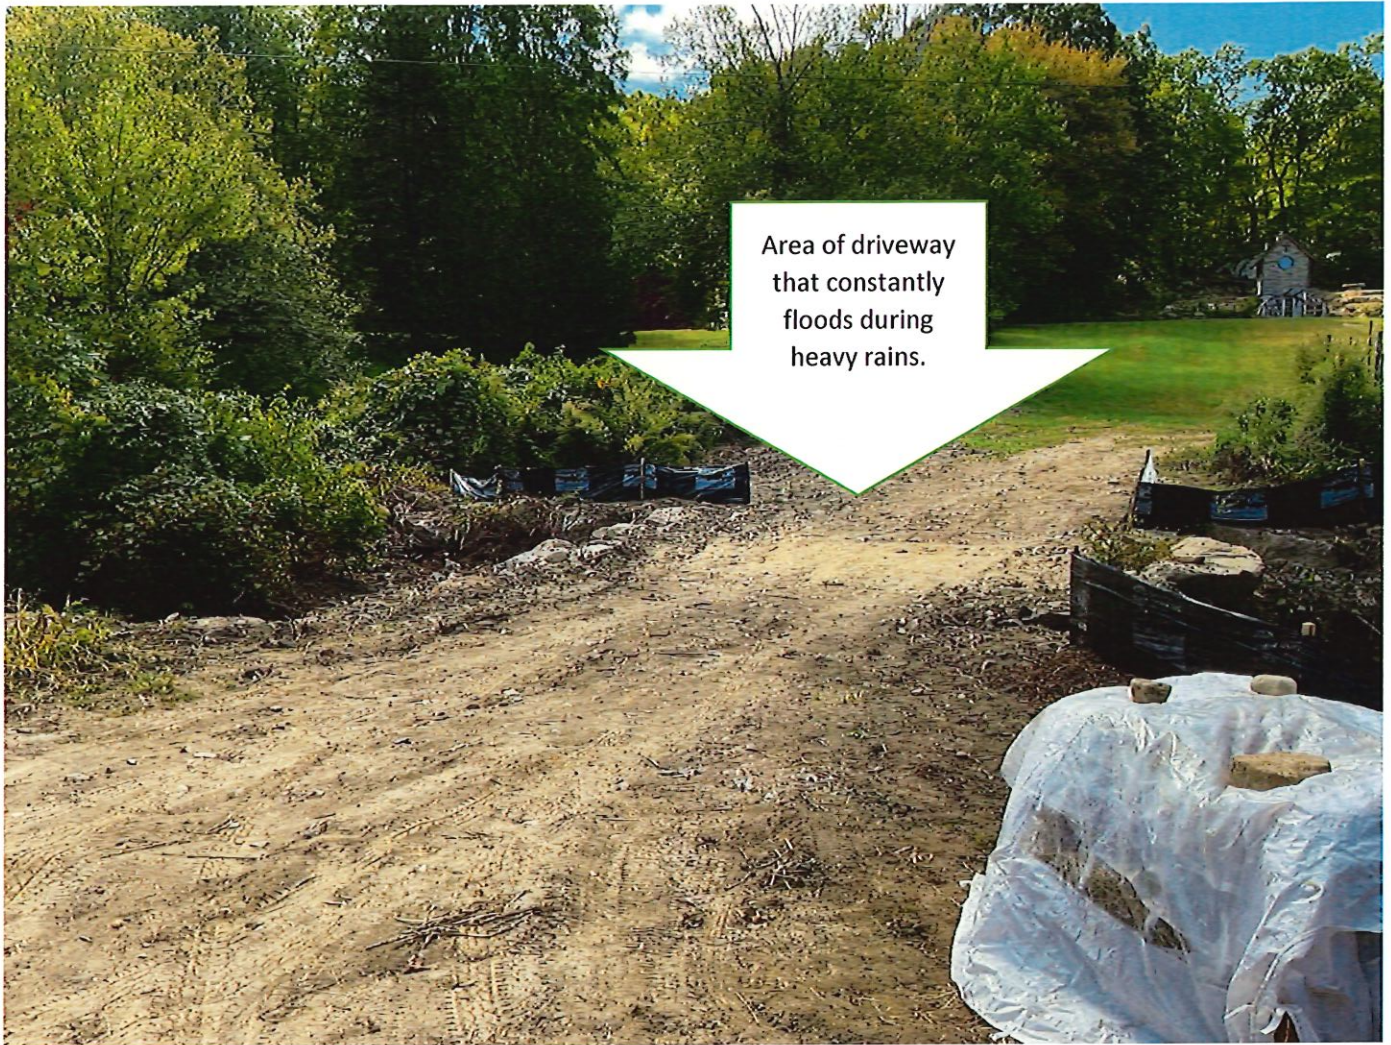
Area of driveway
that constantly
floods during
heavy rains.

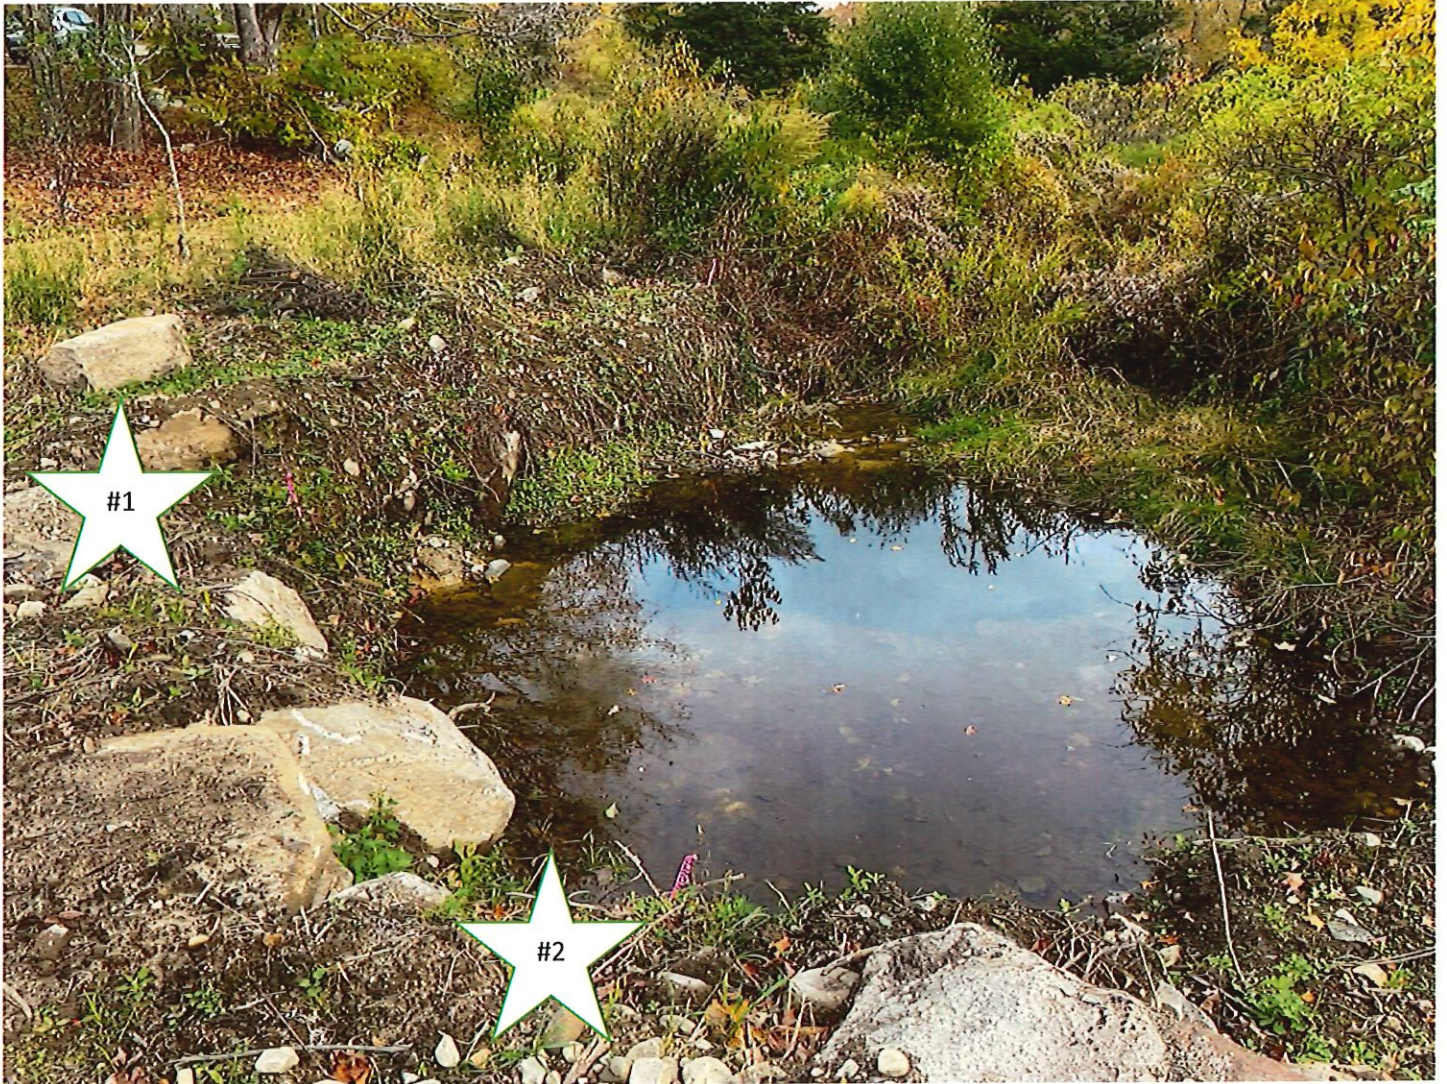
Site inspection shows flags placed throughout both wetland areas. The wetland area #1 to the left of the driveway has (4) flags placed (shown in pictures 1-2) and wetland area #2 has (5) flags placed (shown in pictures 3-4).
