August 23, 2024

Re: Wetland Summary Letter
2268-2284 Route 32
Montville, CT

A Registered Professional Soil Scientist (RPSS) from Lucas Environmental, LLC (LE) conducted a site investigation on July 19, 2024, to determine if wetland resources or watercourses were present on or near the property located at 2268 – 2284 Route 32 in Montville, Connecticut (i.e., Study Area). Please note that this effort is specific to wetland resources; it does not evaluate constraints related to local planning or zoning requirements, historical or cultural significance, nor does it evaluate the potential for soil, air, or water contamination.

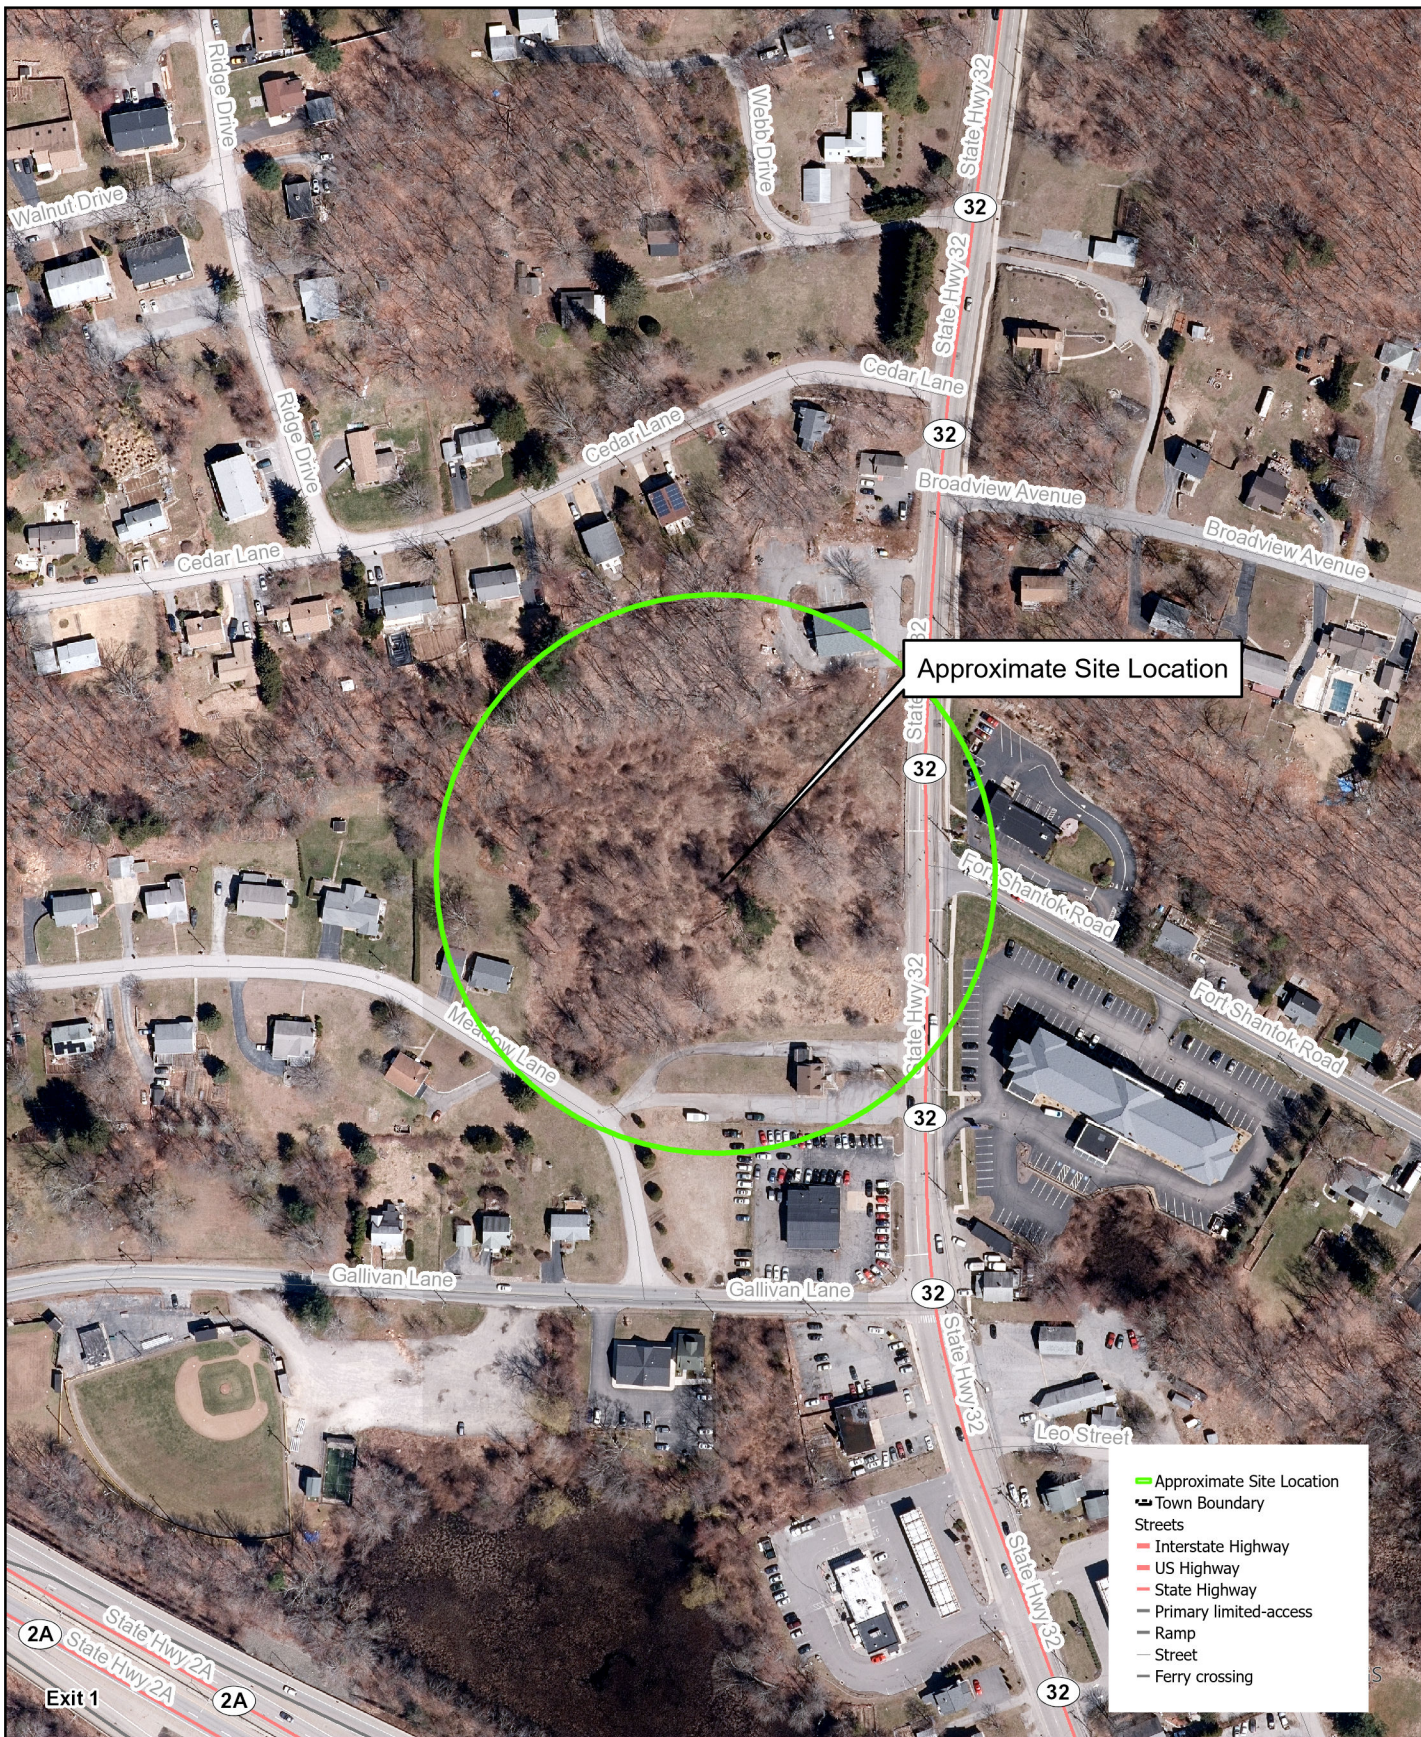
Source: Connecticut Environmental Conditions Online; 2019 Aerial Imagery

Aerial Map **Wetland Summary Letter** **2268-2284 Route 32** **Montville, Connecticut**

The Study Area is comprised of three parcels totaling approximately 3.4 acres of land at 2268 – 2284 Route 32 in Montville, Massachusetts (See Figure 1 – USGS Map and Figure 2 – Aerial Map). The parcels are identified as follows:

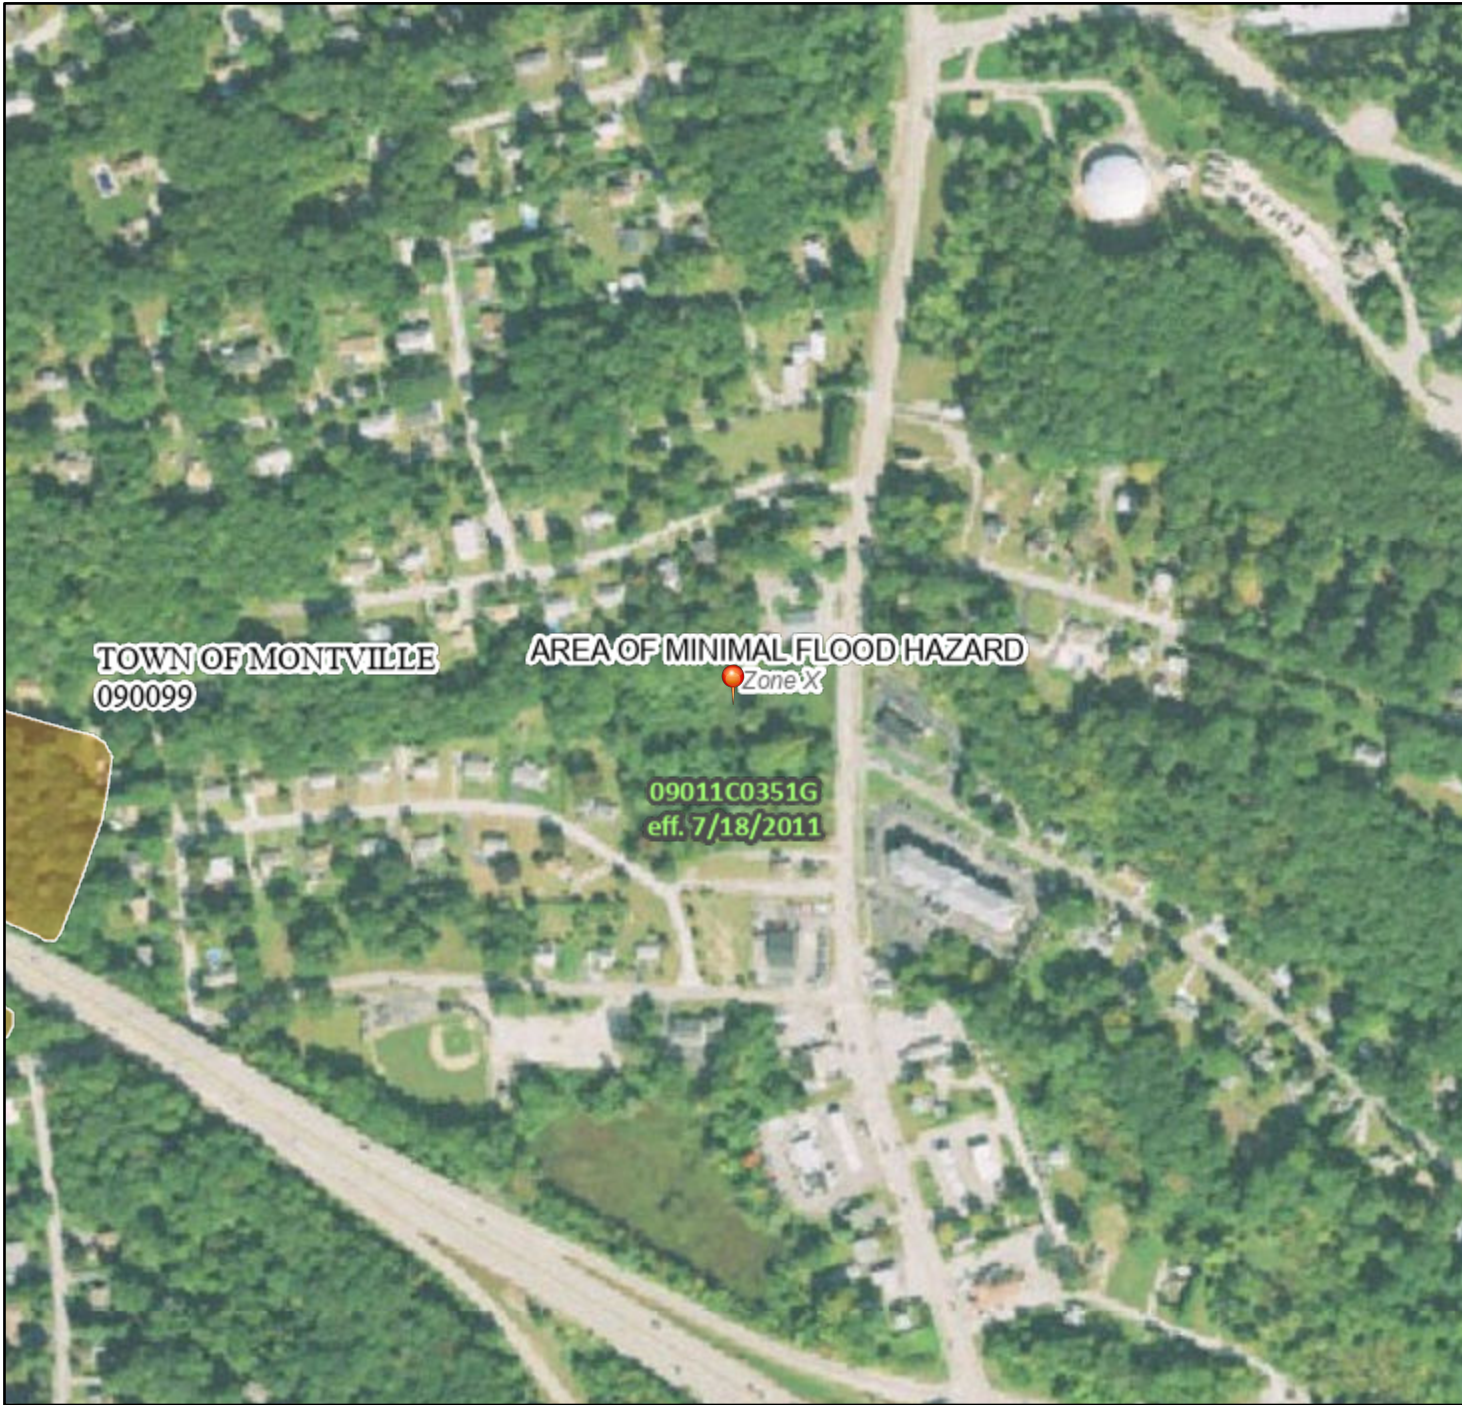
FIGURE 4

National Flood Hazard Layer FIRMMette

According to the July 18, 2011 Federal Emergency Management Agency (FEMA) Flood Insurance Rate Map (FIRM) for New London County, Connecticut, Map Number 09011C0351G, the property is located within a mapped Zone X Area of Minimal Flood Hazard, which is classified as areas outside the 0.2% annual chance floodplain (500-year floodplain) (See Figure 4 – FEMA Map). Therefore, the property falls outside the 100-year floodplain.

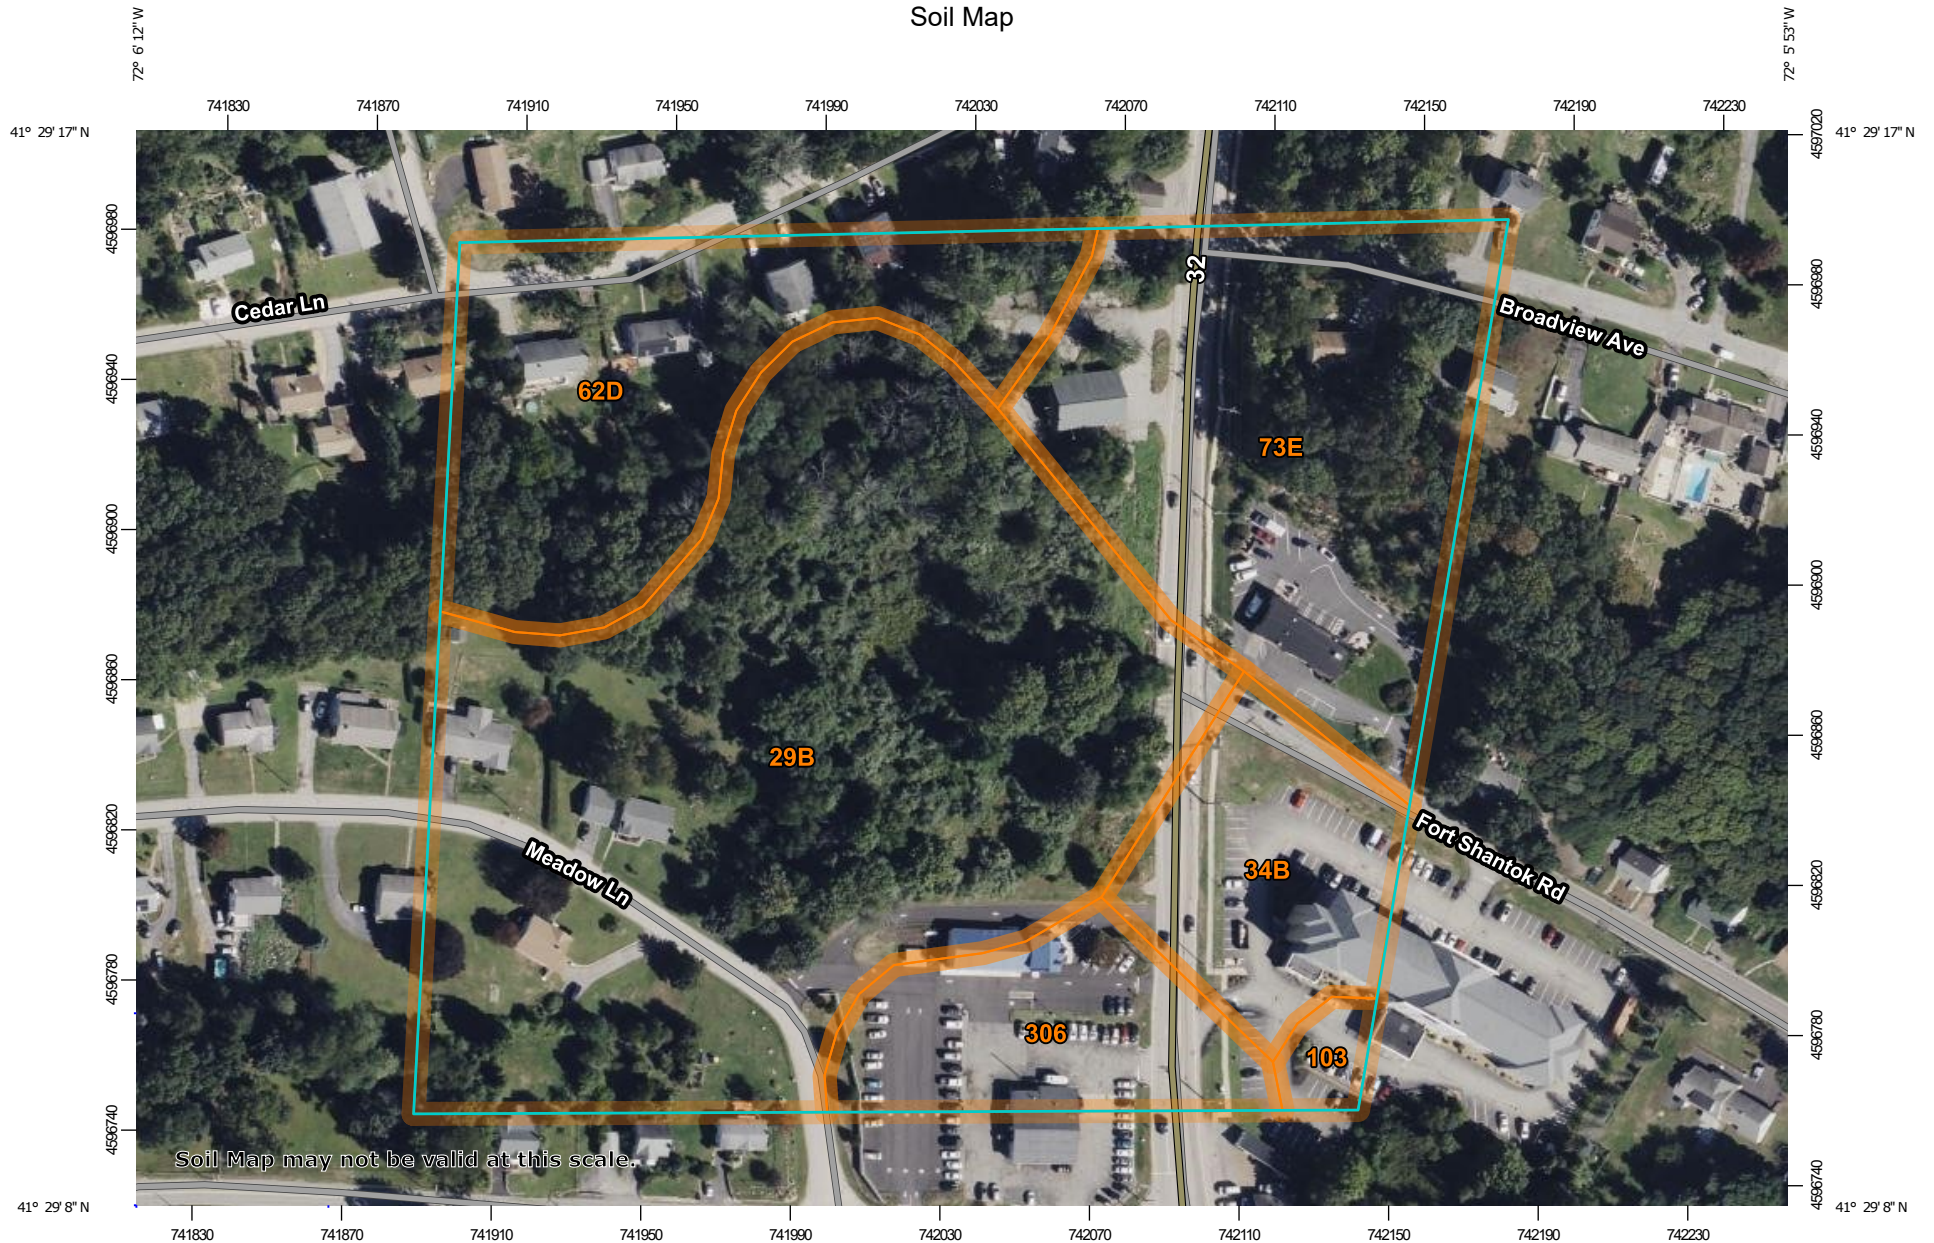
Custom Soil Resource Report Soil Map

The soil map section includes the soil map for the defined area of interest, a list of soil map units on the map and extent of each map unit, and cartographic symbols displayed on the map. Also presented are various metadata about data used to produce the map, and a description of each soil map unit.

Map Unit Symbol	Map Unit Name	Acres in AOI	Percent of AOI
29B	Agawam fine sandy loam, 3 to 8 percent slopes	7.2	46.4%
34B	Merrimac fine sandy loam, 3 to 8 percent slopes	1.2	7.8%
62D	Canton and Charlton fine sandy loams, 15 to 35 percent slopes, extremely stony	2.5	16.3%
73E	Charlton-Chatfield complex, 15 to 45 percent slopes, very rocky	3.3	21.0%
103	Rippowam fine sandy loam	0.2	1.0%
306	Udorthents-Urban land complex	1.2	7.5%
Totals for Area of Interest		15.5	100.0%

A description of each soil map unit identified in and near the Study Area is presented in the attached NRCS Custom Soil Resource Report (enclosed). The soils in the vicinity of the Study Area are generally consistent with the published data. The soil information for the site includes the following soil map unit:

- 29B – Agawam fine sandy loam, 3-8% slopes;
