**RE: WETLAND AND WATERCOURSE DELINEATION REPORT
47 SHARP HILL ROAD
MAP 23, LOT 63
19.13 +/- ACRES
MONTVILLE, CONNECTICUT**

WETLAND SKETCH

47 SHARP HILL ROAD

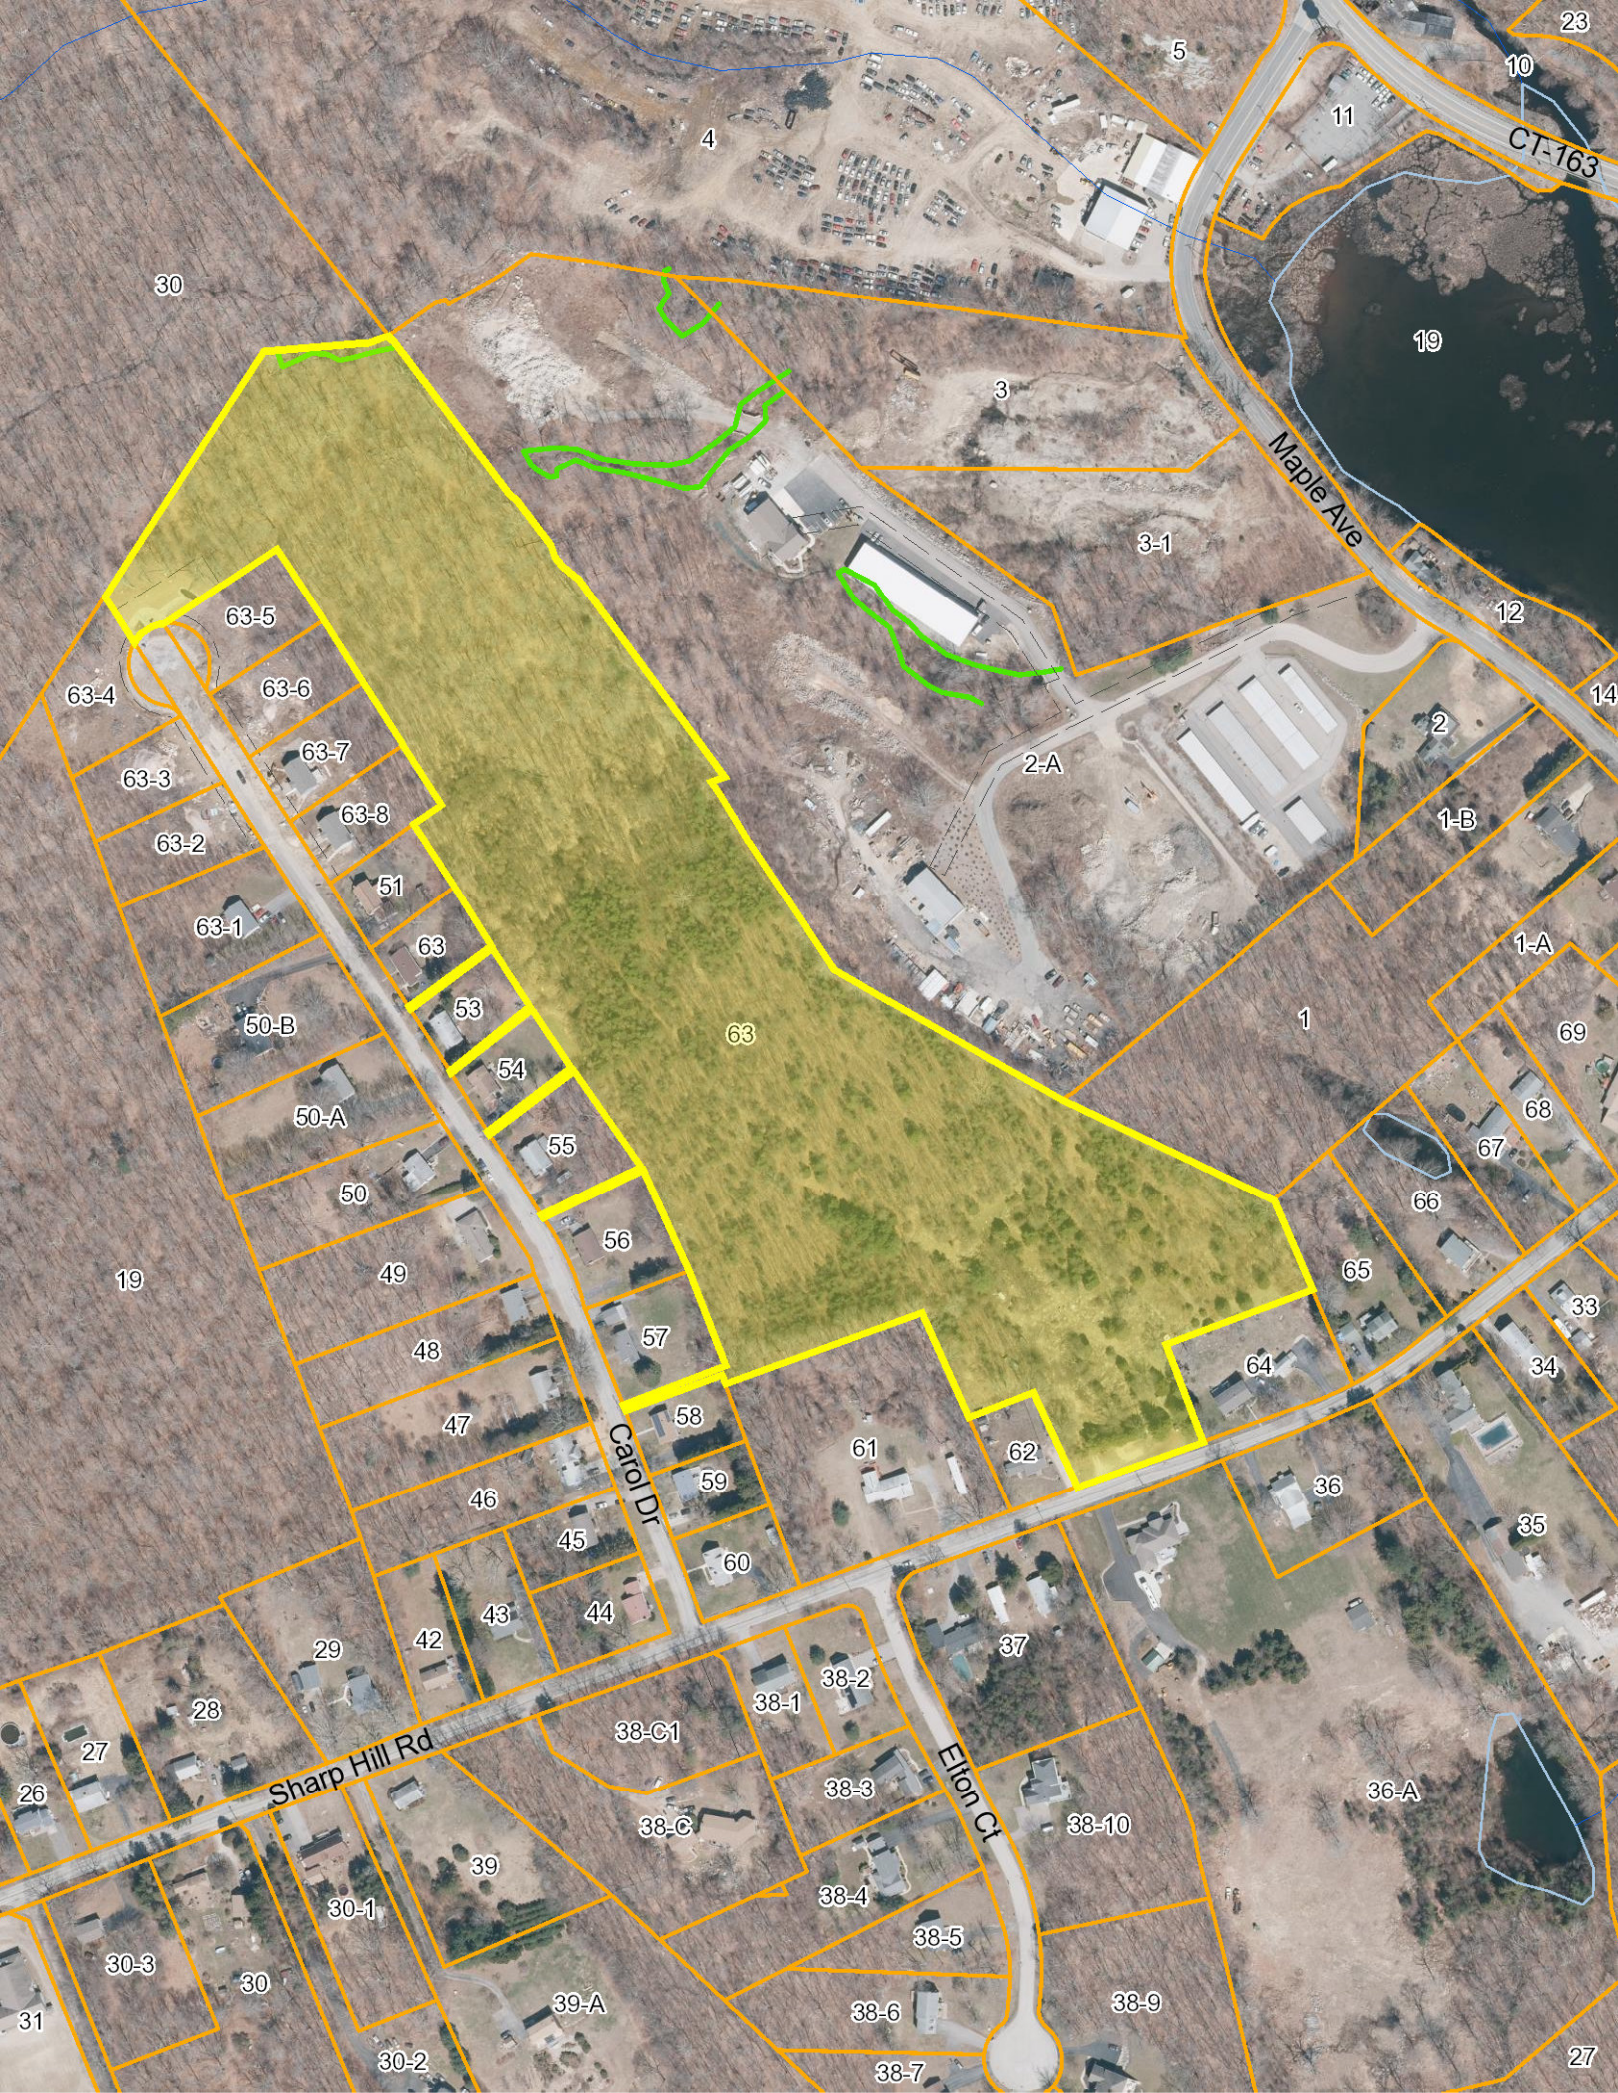
WETLAND #2

WF#2-1 TO WF#2-4

WETLAND #1

WF#1-1 TO WF#1-9

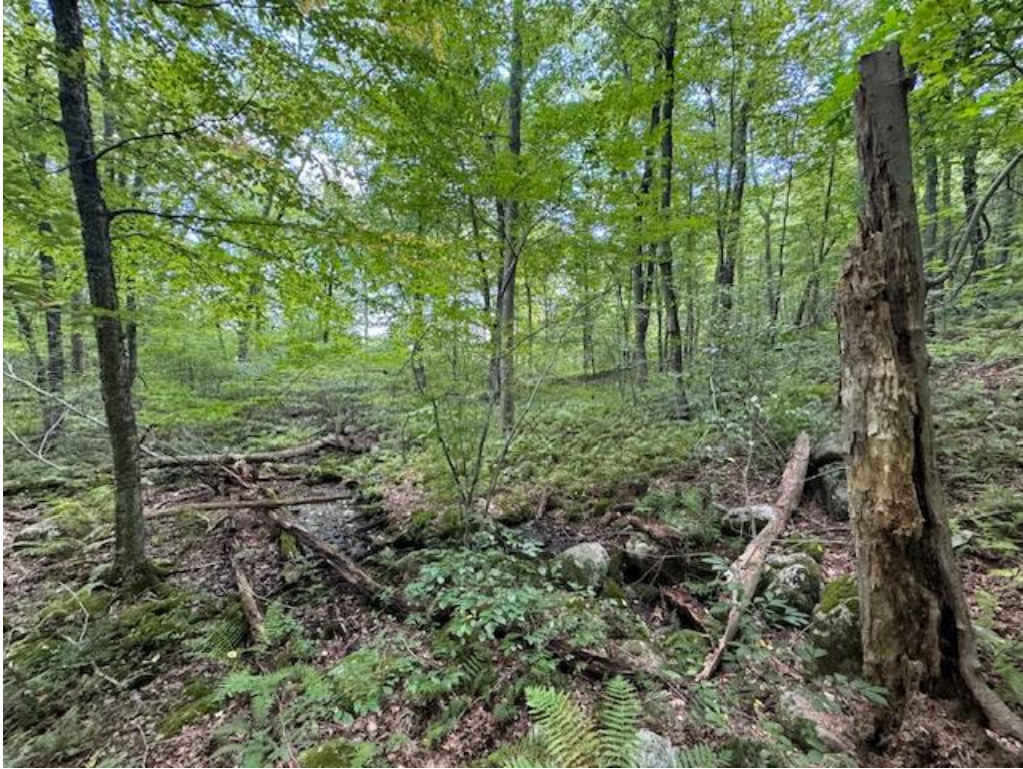
Photo 1: Example of Wetland #1 – Hillside Spring

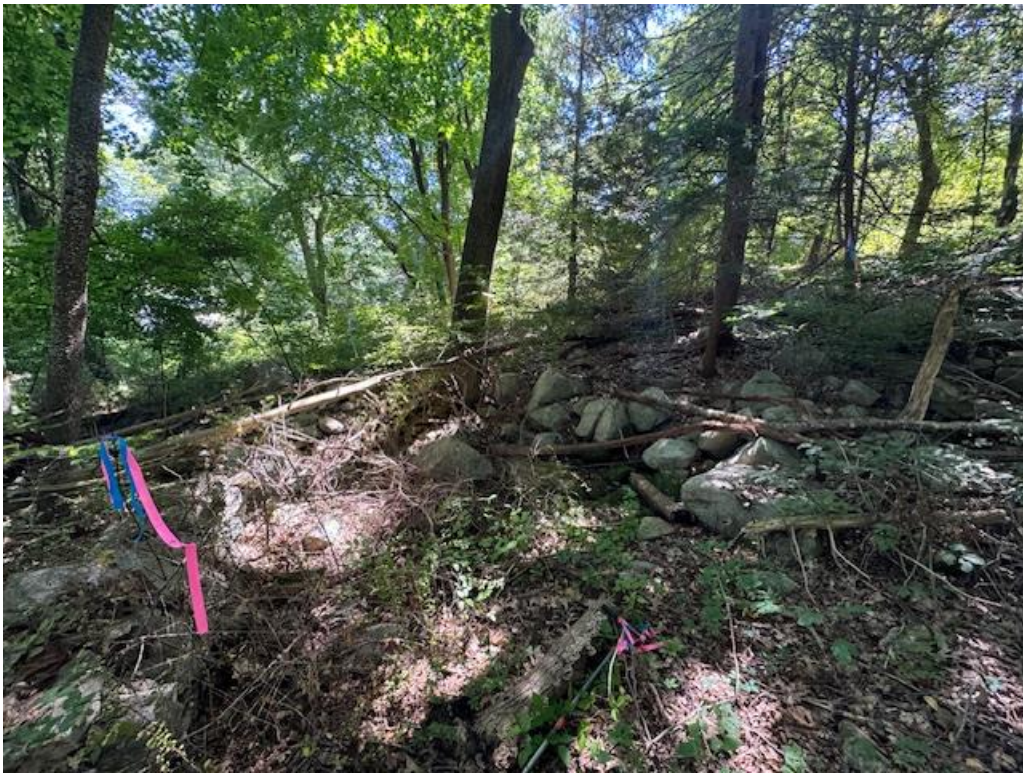
Photo 2: Example of conditions at Wetland #2, Spring that discharges from base of rock pile forming source of intermittent watercourse that flows east offsite.

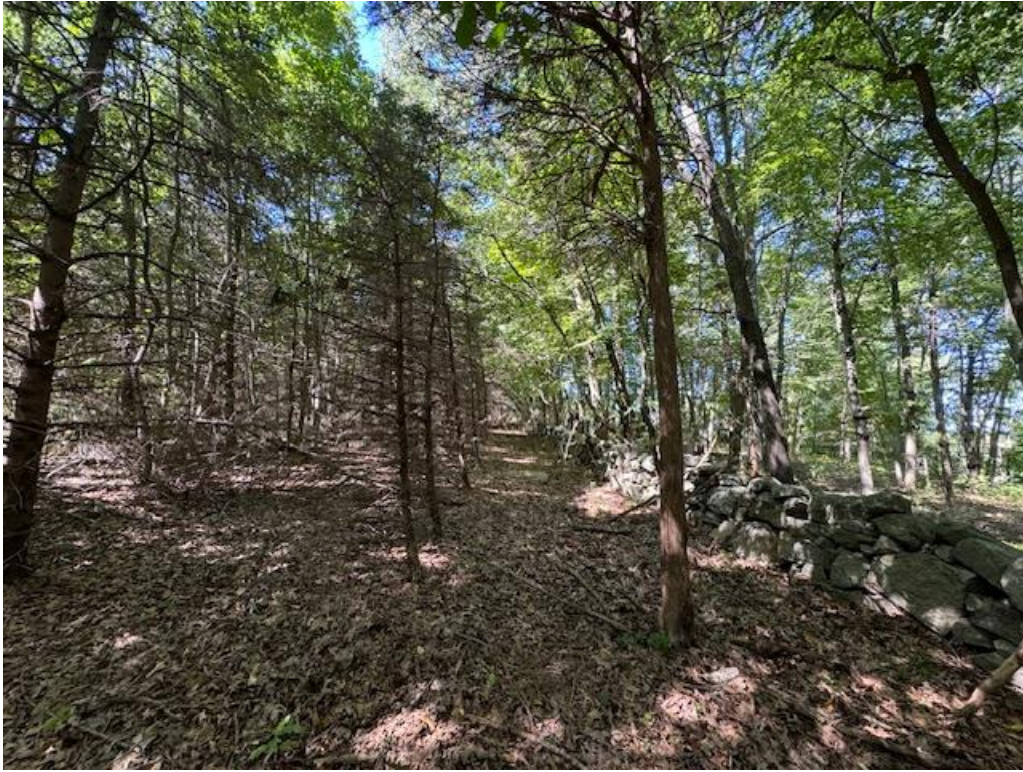
Photo 3: Example of typical conditions of the upland forest in the south half of the property, note dense young growth of trees.

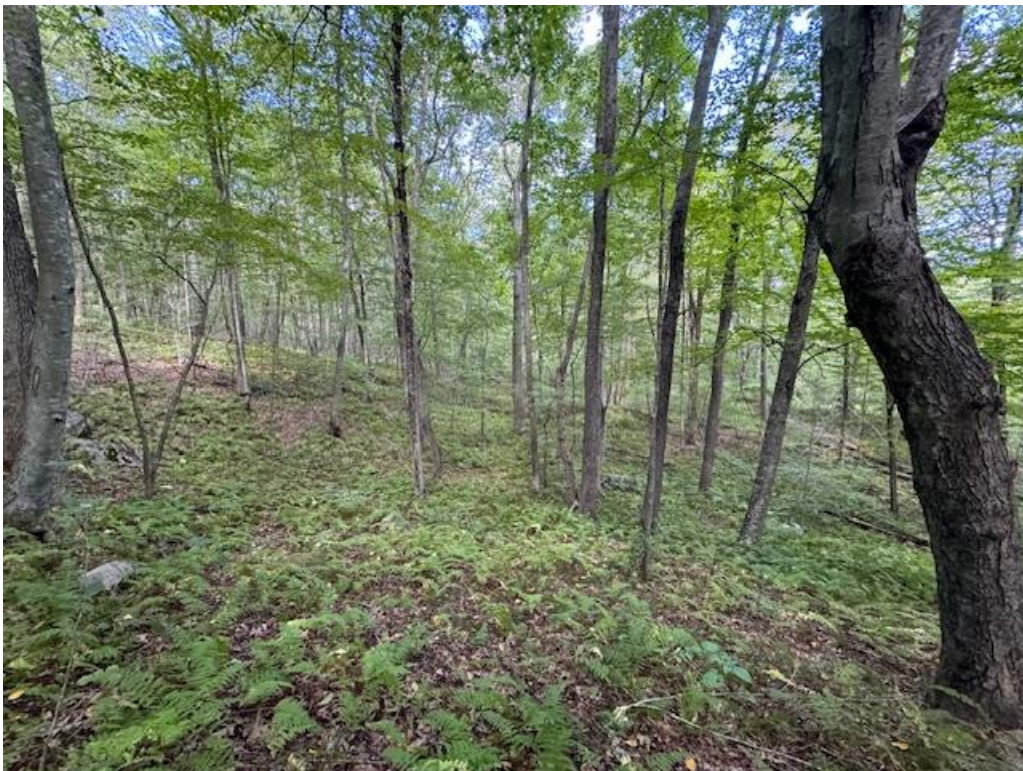
Photo 4: Example of the mature park like forest that covers the northern half of the site.

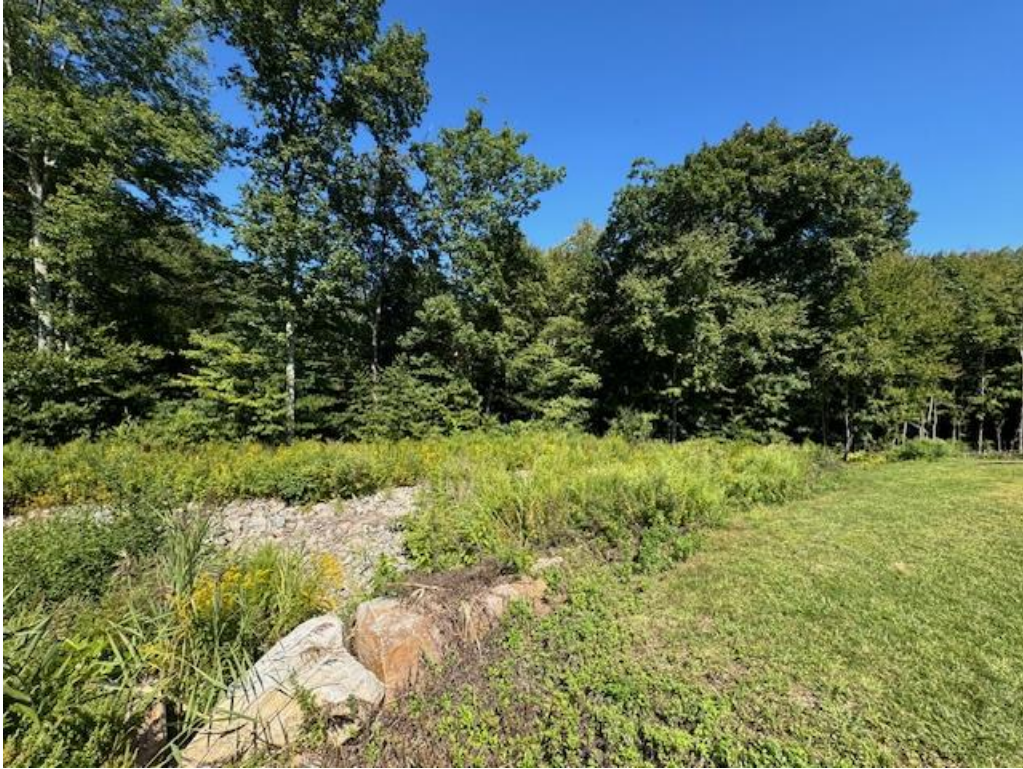
Photo 5: General conditions at end of Carol Drive and example of the man-made stormwater drainage features that have been somewhat recently installed.
