Town of Montville Inspection Report

Date: 10/15/2025 Inspection Type: Wetlands Complaint

Location: 428 Fire Street Map/Lot/Block: 014-003-000

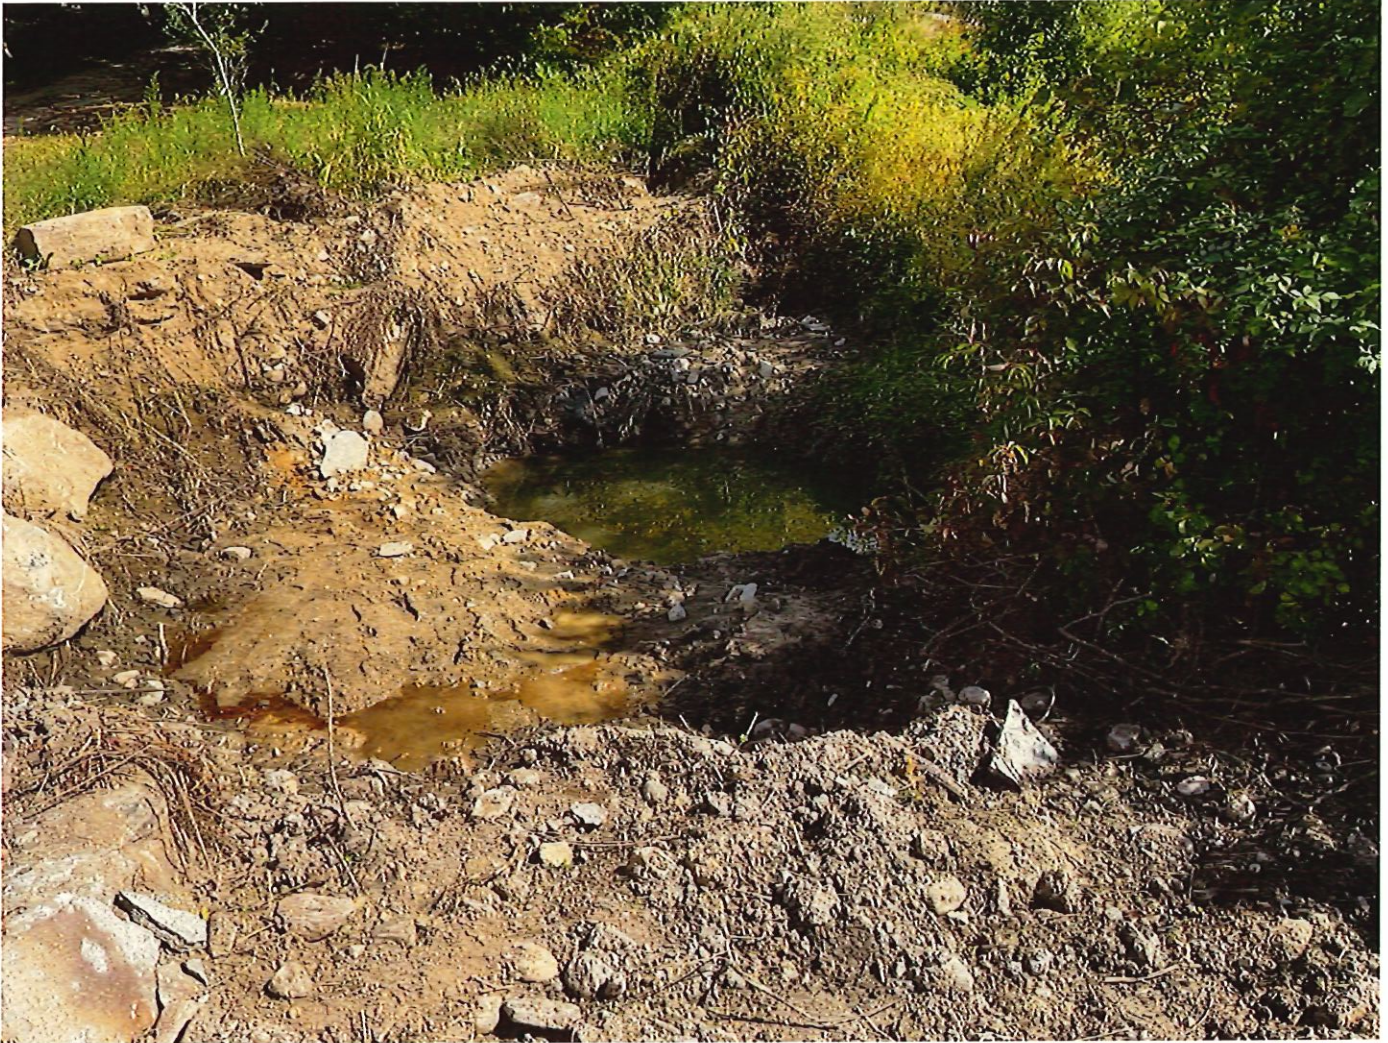
Property owner claims that the reason for the work was because of constant flooding of the driveway during heavy storms.
